Water Quality Programs

Gary Esslinger

Thursday, December 02, 2010

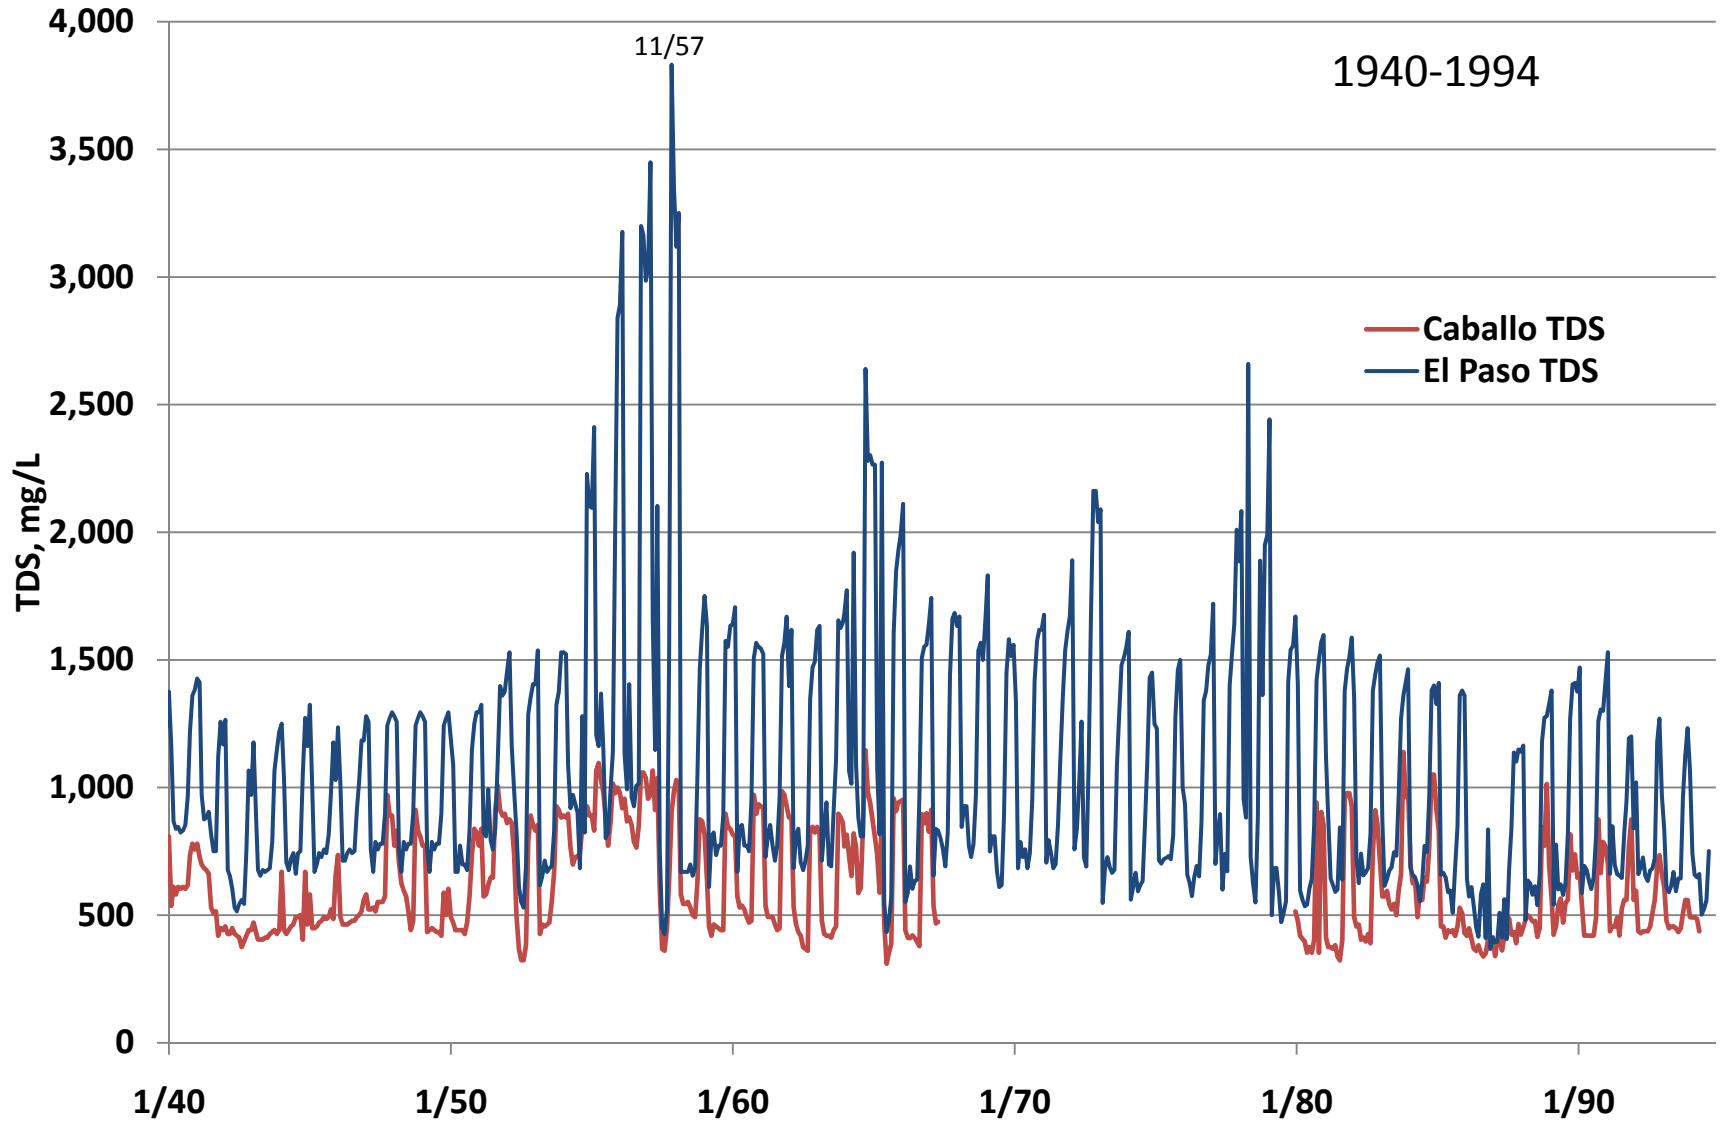
Long-term Salinity (TDS) General Behavior

- Strong intra-year seasonal cycle – High TDS with low winter flow, low TDS with high release flow
- Strong inter-year drought cycle – High TDS in drought, low TDS in wet years, except immediately following drought
- No long-term increase in TDS
- Strong geographic trend – Increasing TDS going downstream

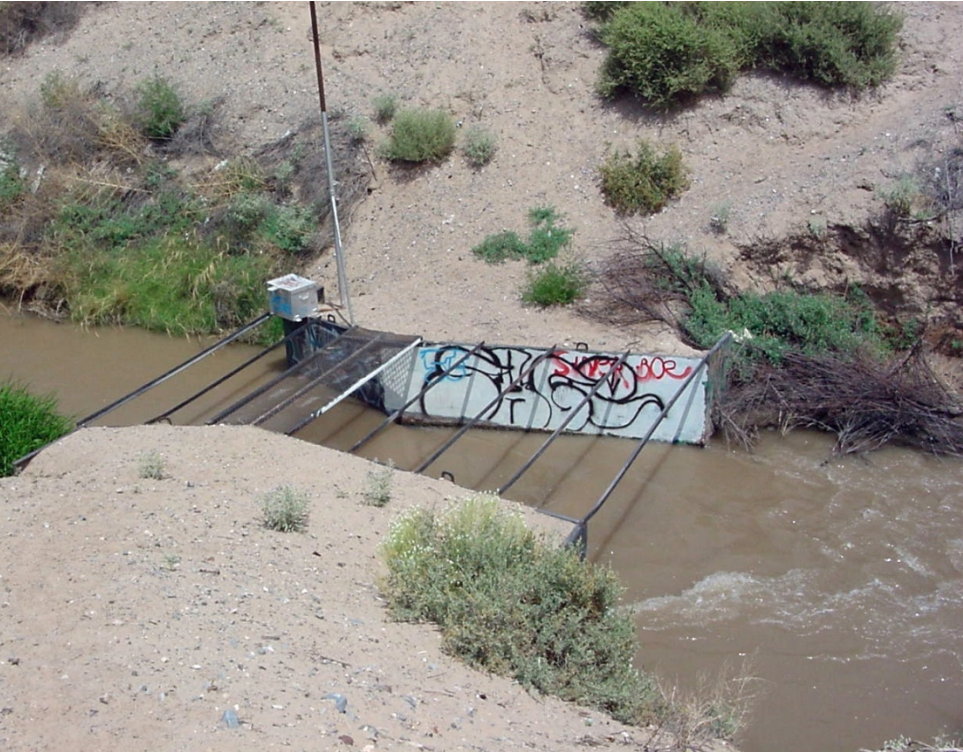
Real-time TDS

- Real-time conductance/temperature meters
- Flow measurement structures
- Del Rio, East La Mesa, Nemexas, West Drains, River at Anthony, EPWU treatment plant (Rio Grande @ American Dam)
- TBA: Montoya Drain, with Acoustic Doppler meter
- Available through EBID web site

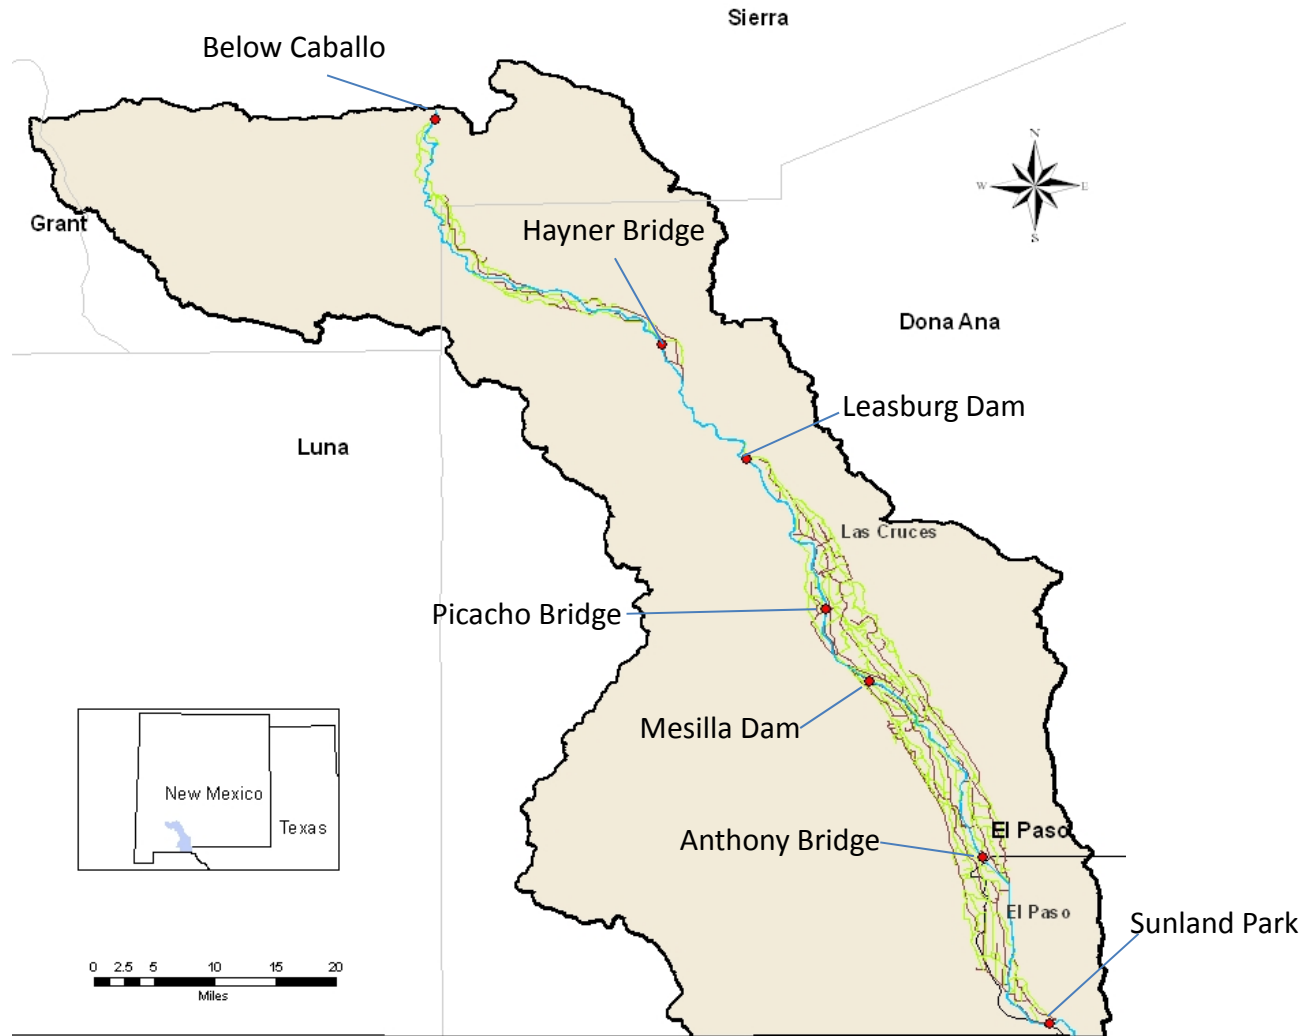
Lower Rio Grande Watershed Routine Sampling Points

Sampling Points

• Routine

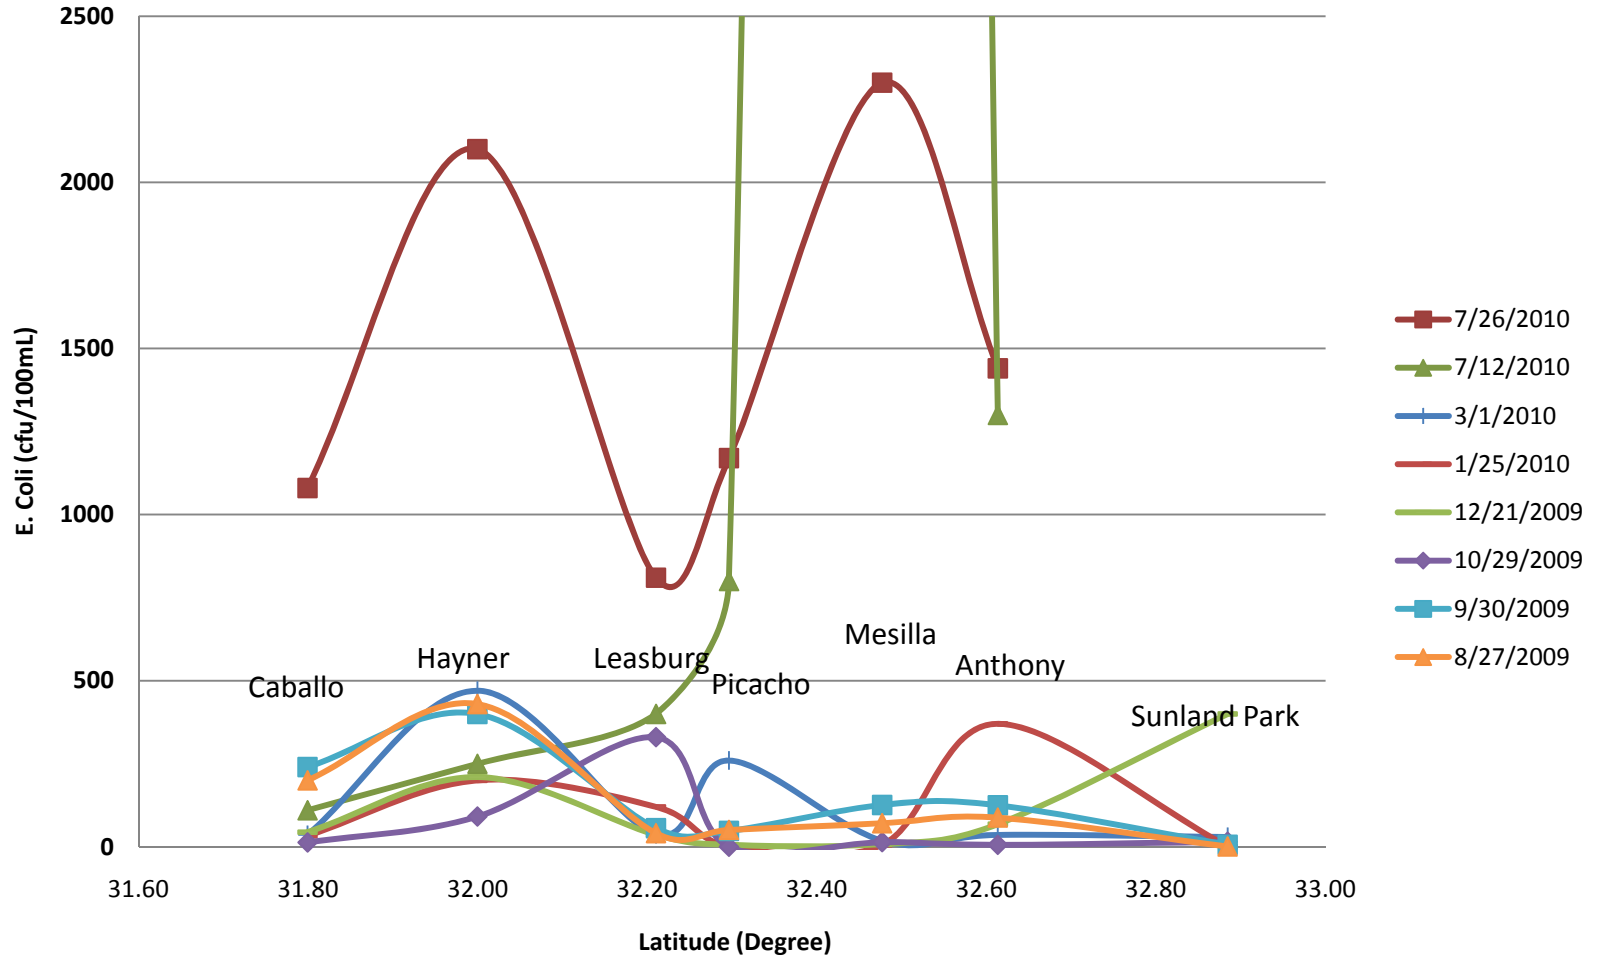
E. coli routine sampling

- Base flow generally below regulatory limit
- Spikes strongly associated with rainfall/runoff events
- Elevated E. coli from runoff events appears regardless of land use
- Next phases:
 - Tracking upstream in drains, arroyos during spikes to identify sources
 - Genetic source tracking (Dr. Geoff Smith, NMSU)
 - Develop source-specific BMP recommendations
 - Storm water capture and control
