The Paso del Norte Watershed Based Plan

*Mitigation Measures to Reduce
Bacterial Pollution in the Rio Grande*

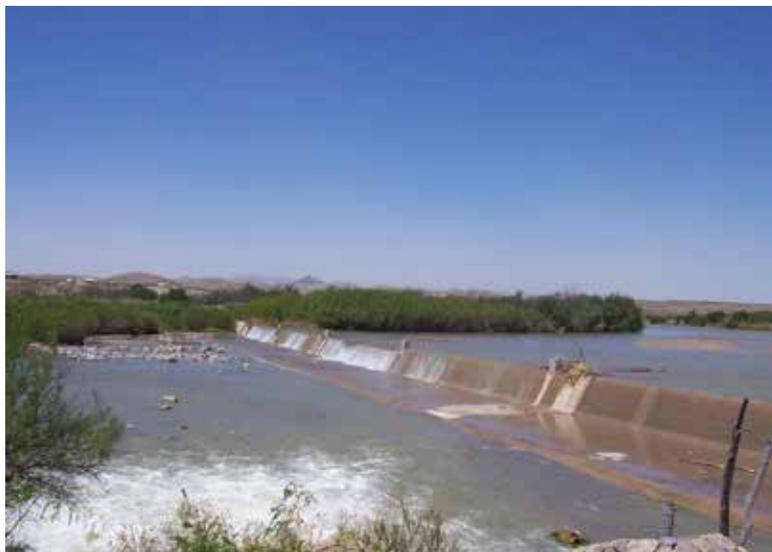
Figure 7: Leasburg Dam, one of three major diversion dams in the watershed.

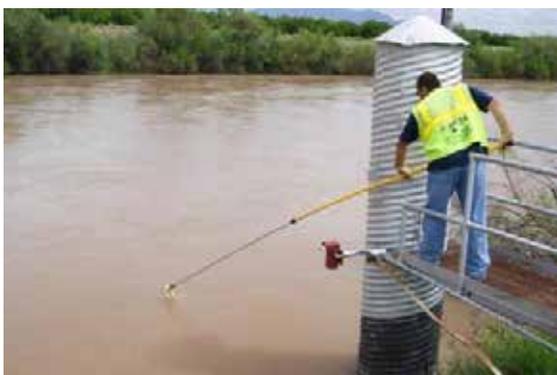
Figure 13: EBID staff collect a sample for *E. coli* analysis at the Leasburg gage on the Rio Grande.

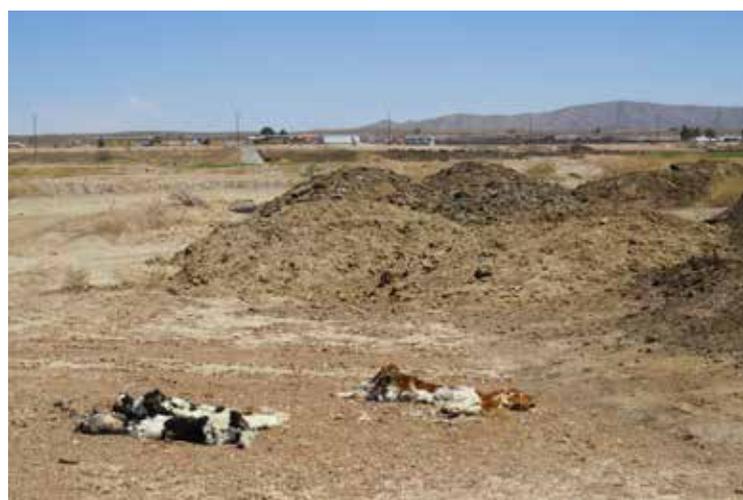
Figure 21: Dairy manure piles and calf carcasses adjacent to the East Drain.

Both the Mesquite Drain and the East Drain run parallel and adjacent to the area known locally as dairy row (\approx 12 dairies) in the Mesilla Valley. Each dairy has in place a Nutrient Management plan to dispose of any land-applied waste that is on the facility or other land utilized by the dairy to grow crops to ensure protection of water resources. However, some of the manure is sold for use as fertilizer. There is currently little regulation governing this activity. On occasion, manure has been stockpiled adjacent to irrigation drains and canals which could facilitate movement into surface waters. In addition, as discussed in the Introduction, there have been reports of airborne distribution of *E. coli* in the literature, indicating the potential for unintentional distribution of *E. coli* without there being a discharge from a dairy. It is unknown if that is occurring here. However, given the close proximity of the drains to the dairies, occasional improper storage of manure, and the annual occurrence of high wind and dust storms, there is the potential for *E. coli* to enter either of the drains.

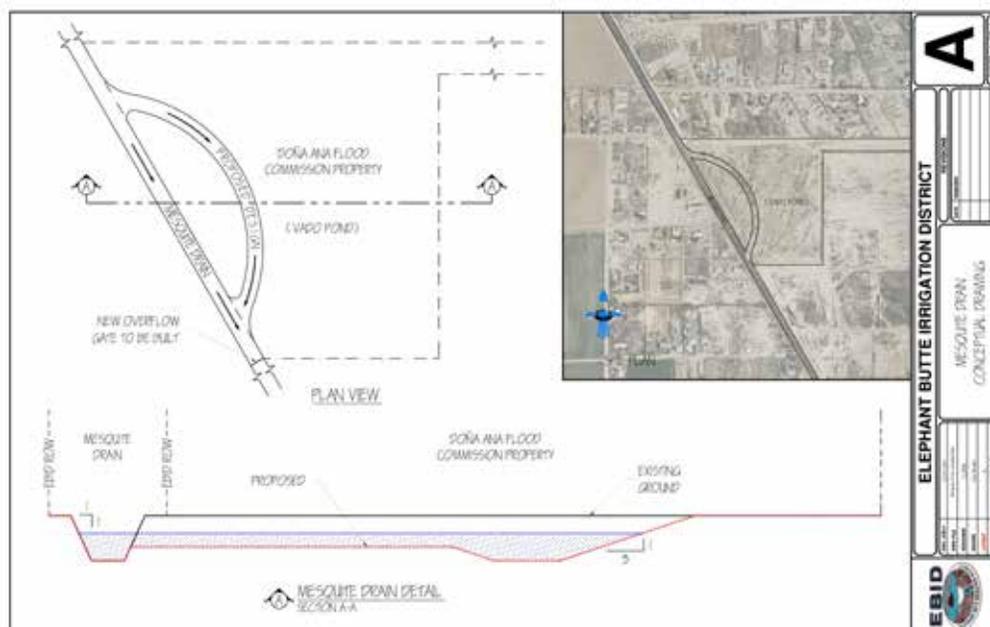
Figure 25: Conceptual design of overflow wetland for Mesquite Drain.

A similar project has been identified to be implemented along Mesquite Drain (Figure 23). The concept has been modified to include a wider floodplain with a secondary channel along the back side to create a sort of oxbow (Figure 25). The drain will be expanded into an adjacent shallow ponding area that already collects stormwater. The expansion will be below the grade of the existing area and provide an overflow ponding area for stormwater coming down the drain from upstream of the site. An overflow drop gate will be installed on the downstream end of the project

to facilitate water retention and controlled release. The estimated retention time will increase from 0.3 days to as much as 12 days depending on the volume of the incoming flow. This will facilitate mitigation of *E.coli* by prolonged exposure to UV radiation and increased infiltration to groundwater.

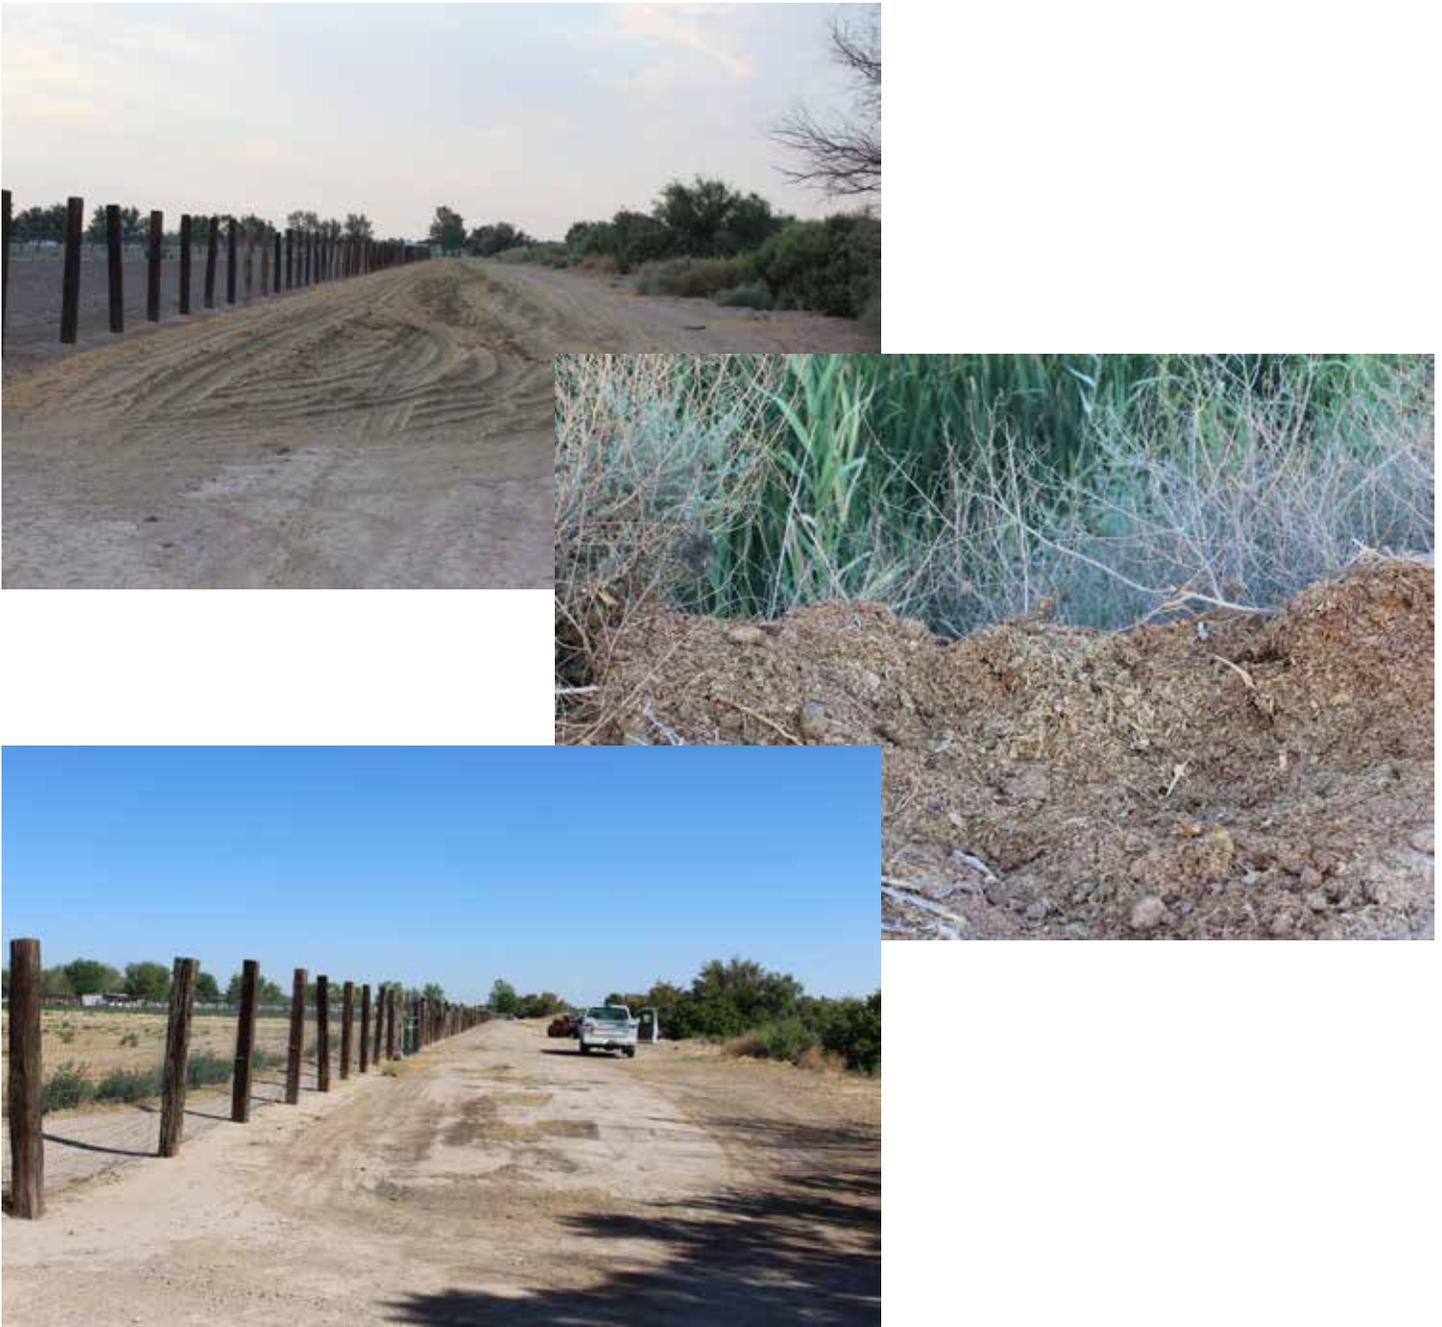
Figure 26: Joint NMED and EBID enforcement with successful outcome. Horse manure and bedding materials placed adjacent to West Drain (top). The pile was 800'x30'x18". A closeup of manure in West Drain at the site (middle right) and following cleanup of the site (bottom).

Beginning in the summer of 2013, NMED and EBID began working jointly to investigate complaints of illegal dumping of manure into the agricultural drains (Figure 26). In the first six months of this effort, three notices of violation were issued by NMED followed by similar notices sent by EBID. These all involved the dumping of horse manure. All three cases were successfully resolved with voluntary cleanup by the alleged violators. The stake-holder outreach component of this BMP will provide information on the importance and function of agricultural drains and issues related to illegal dumping.

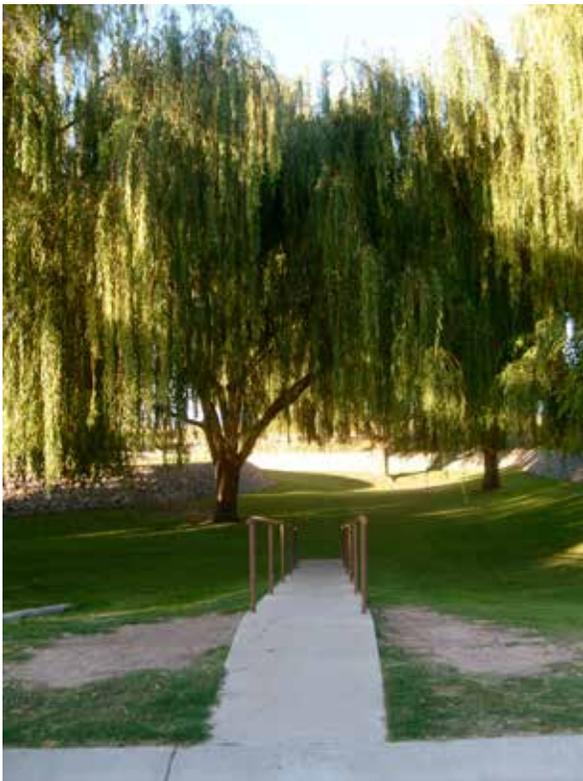
Figure 28: Detention basin serving as a park in Mesilla, New Mexico.

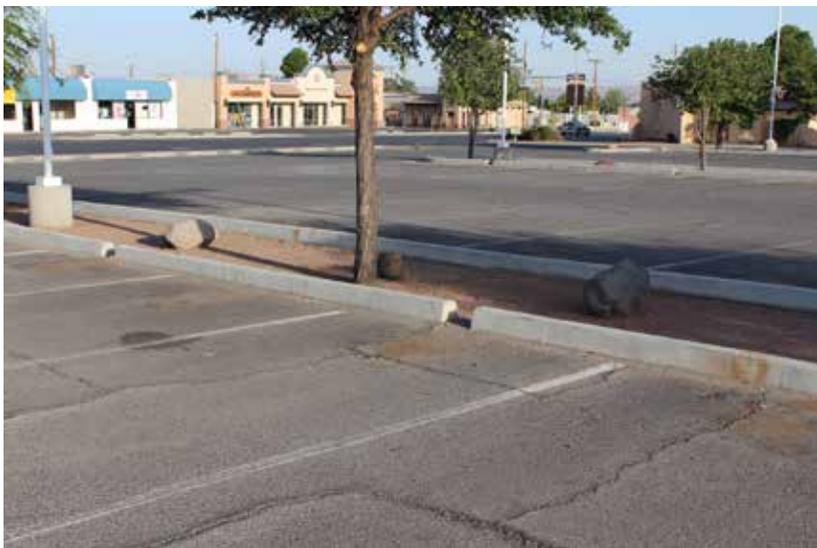
Figure 29: Curb cuts in a parking lot providing irrigation to median.
